Whittenton Village Walk Audit Report

Whittenton Village Walk Audit Area Map

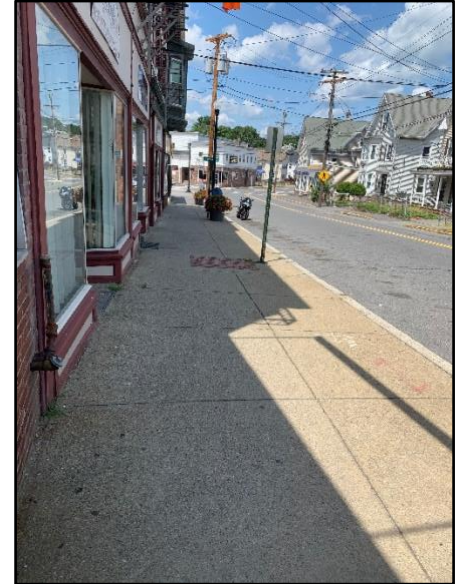
The walk audit began at the parking lot of Regal Liquors and Food mart, on the West side of Bay Street heading North toward Whittenton Street. Bay Street is a two lane road with vehicles traveling North and South, and both lanes are relatively wide. The sidewalks on the West side of the street are as well. For the most part, the sidewalks are in fine condition, with relatively no tripping hazards or uneven footing.

West Bay Street sidewalks facing North

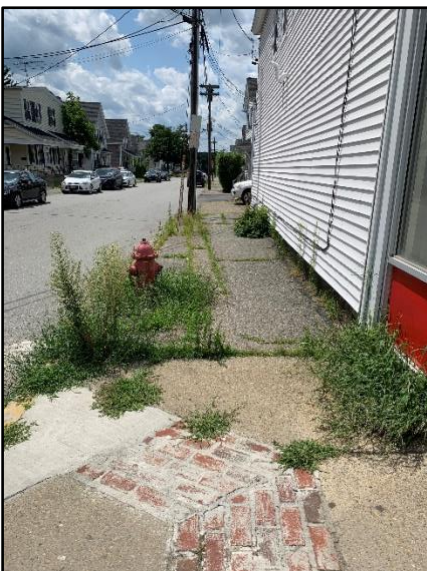
At the intersection of Bay Street and State Street, curb cuts are present, but a crosswalk is noticeably missing. Adding even just a simple crosswalk could improve visibility of pedestrians possibly crossing as vehicles approach this intersection. The sidewalks around the curb cut are cracked and not in quite the condition that the remainder of sidewalks are, but still do not pose much of a tripping or fall hazard. On the North Side of State Street, there is significant brush overgrowth surrounding the fire hydrant, which is aesthetically not pleasing, and could serve as a potential trip hazard.

State Street Overgrowth

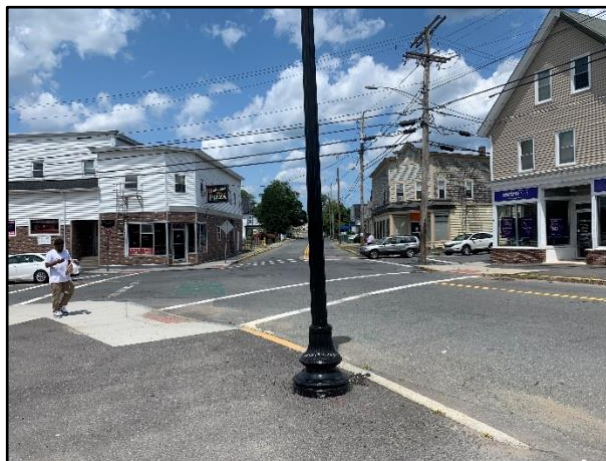
As you approach Whittenton Street from Bay Street, you come to a large four way intersection. This intersection features curbs with very large radii and wide turns. Crosswalks and curb cuts exist at all four points of the intersection and are in decent condition. There are no stop signs on Bay Street heading North or South. There are stop signs on both the Whittenton Street sides of the intersection, set back about 20 feet from their respective street corners. Because the curb radii are so large, vehicles often stop and pull directly into the crosswalk area to get a better sense of oncoming traffic from Bay Street. These wide turns also encourage speeding, as tighter turns require drivers to slow down.

Whittenton & Bay Street Intersection
Large radii and cars in crosswalk

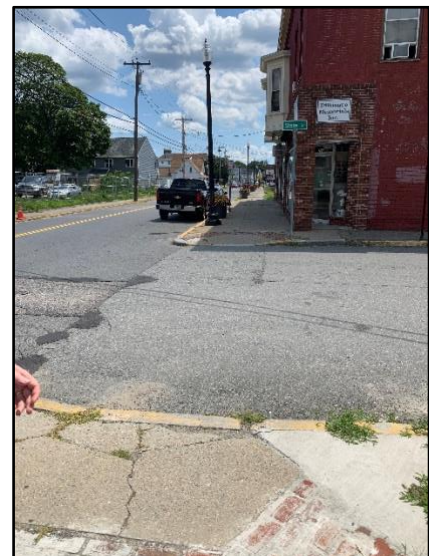
Bay and State St – Missing Crosswalk

Many of the crosswalks could use repainting. In order to increase visibility of the crosswalks, installing “zebra stripe” or “piano key” styles helps vehicles identify crosswalk locations and slow down more readily. Using paint is low cost and it can be an effective strategy.

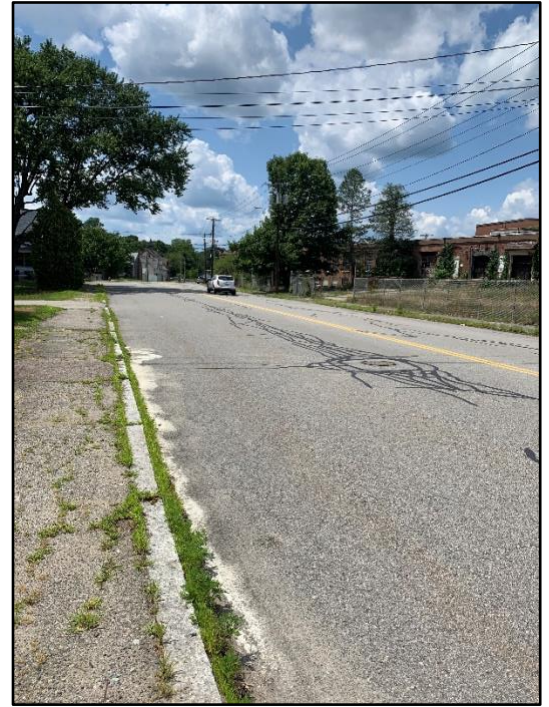
Whittenton Street is another wide-lane road. The walk audit route along Whittenton stretched from the Bay Street intersection down to the Mill River crossing. Starting down Whittenton heading West, the sidewalks are in fine condition, but slightly narrow considering the large width of the Street. As you arrive in front of St. Jude's Parish, there is a visibly painted crosswalk, which lacks curb cuts. This adds an extra layer of danger for pedestrians, as they already have to navigate that crossing as vehicles pull perpendicular into the parking spaces in front of the Church. Continuing down to the intersection of Whittenton and Lawrence Street, the sidewalks on both sides also lack curb cuts.

Whittenton Street heading West

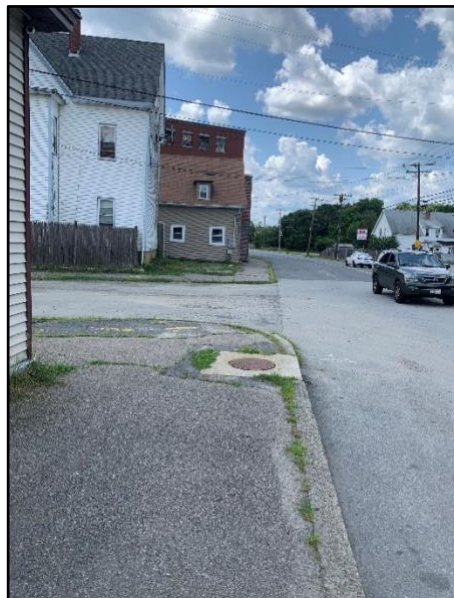
**Lack of curb cuts at
Whittenton and Lawrence St**

Numerous spots along the walk audit route were missing curb cuts. Locations like Lawrence Street, the Four Corners intersection (West Britannia/East Britannia and Bay Street), and others listed previously would all greatly benefit from state of the art curb cuts. Not only do they make intersections safer for people of all abilities, but also reduce tripping hazards and make pedestrians more visible. Smooth sidewalks free from any protrusions or changes in elevation also provide a much safer pedestrian friendly area. Improving these pieces of infrastructure could dramatically increase the walkability of the Whittenton Village area, leading to increases in property values, economic development, and possibly much more.

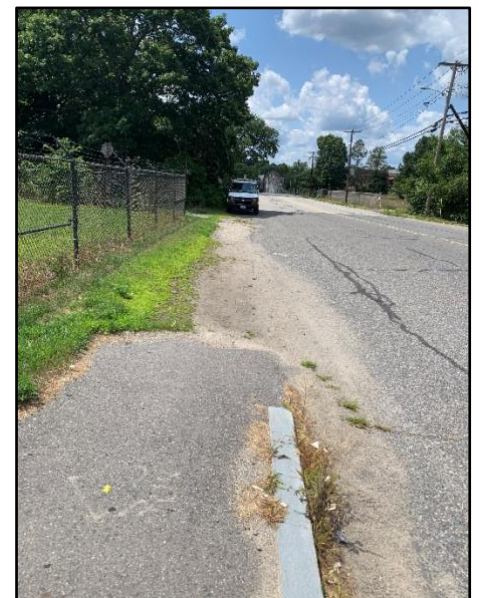
The sidewalks past Lawrence St continue to be in adequate shape on Whittenton until you get to the intersection with Cottage Street near the rail road right of way. Here, the sidewalk ends and becomes a grassy patch. During the time of the walk audit, a utility vehicle was seen parked directly on the path forward, which forces pedestrians onto the street. The remainder of Whittenton Street heading West is in adequate shape up until the Mill River crossing.

**Sidewalk ends near RR right of way
Utility truck blocking path**

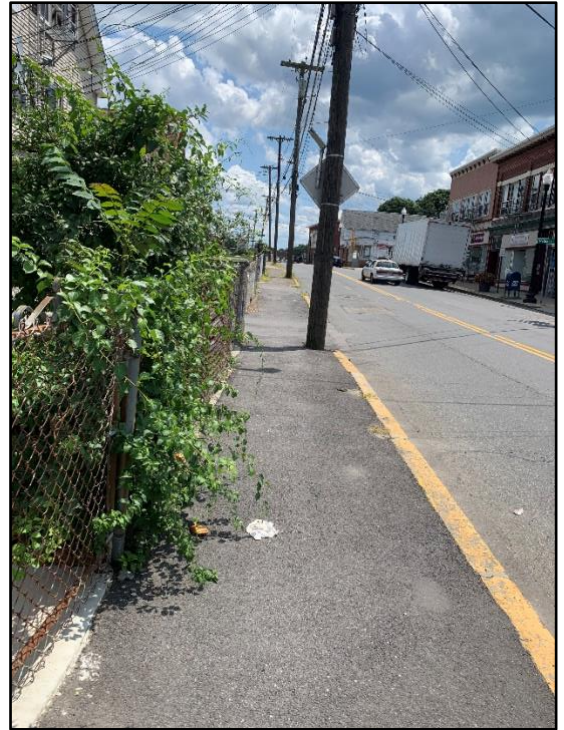
Back at the Bay Street and Whittenton Street four way intersection, the walk audit crossed over to the East side of Bay Street. Traffic from all sides of the intersection flowed smoothly, and crossing was relatively easy. Heading South on Bay Street, the sidewalks were very narrow, and there were multiple points where two people side by side could barely fit past a utility pole or overgrowth. At Pulaski Square, at the intersection of Bay and East/West Britannia, the crosswalks are faded. The South side of this intersection also lacks curb cuts.

Narrow sidewalks and overgrowth

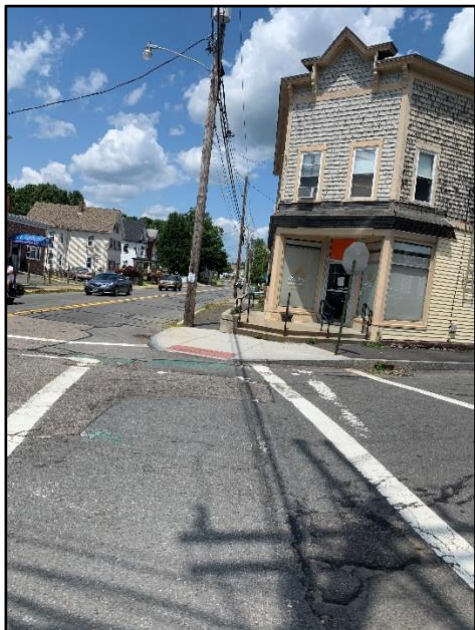
"3 Corners" intersection crossing Bay St

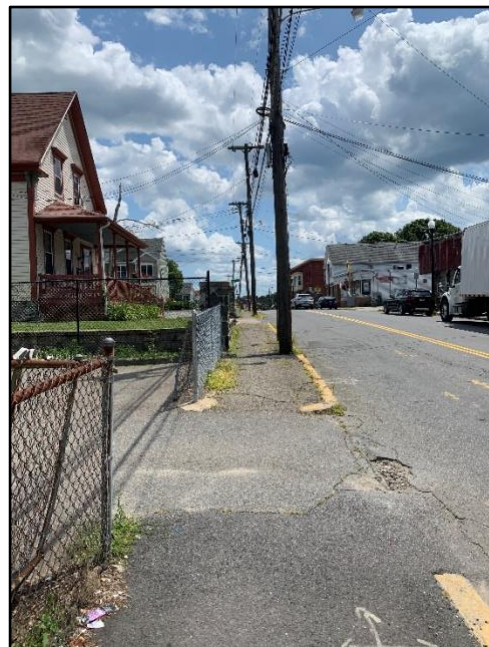
Past East/West Britannia Streets, the sidewalks on East Bay are in terrible shape. There are numerous breaks in the pavement, and elevation changes from raised or cracked sidewalk. These create serious tripping hazards, especially where the sidewalks are narrow and hard to get through in general. This continued all the way down Bay Street until the walk audit turned around between Madison and Monroe Streets.

Narrow sidewalks and frequent utility poles

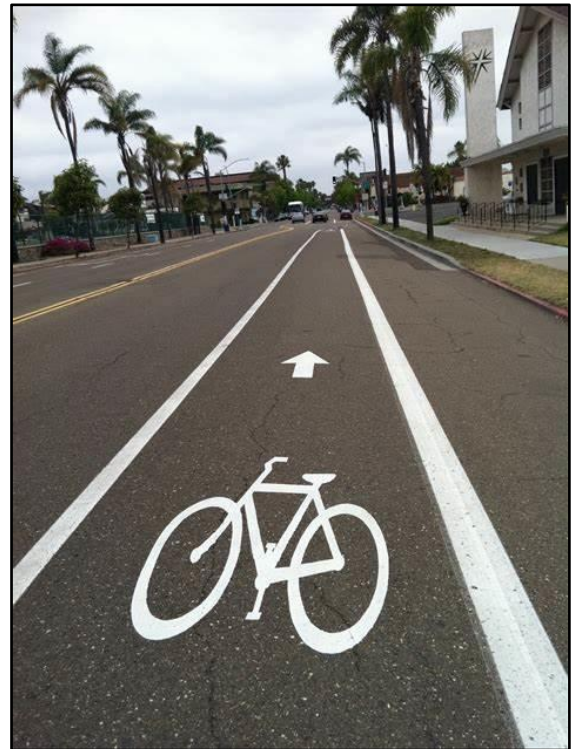
Creating bike lanes, especially on very wide roads like Bay St and Whittenton Street, not only gives bikers a safer space to ride but also helps create a safer environment for pedestrians and motorists alike. Pedestrians will have an additional buffer from traffic. Using bike lanes, sharrows, or additional painted “fog lines” to narrow the road without large infrastructure projects is yet another for effective low cost improvements.
